THE GROUND FLOOR

What It Takes To
Provide a Solid
One-Piece Foundation
for '68-'72 Chevelles

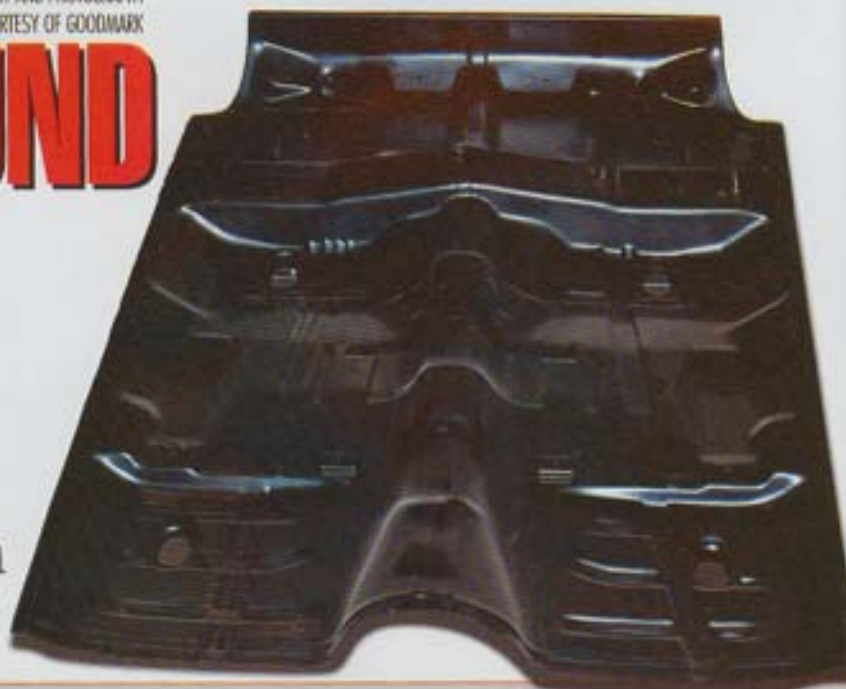
Ron Whitehurst's car is receiving the first prototype of Goodmark's one-piece floor to verify in-field replacement. Understand that this amazing piece is a complete floor that runs from the front section (foot wells) all the way up to the beginning of the C-pillar section. Before making the first cut, Craig Hopkins locked the pan over to make sure that all factory bracing and brackets were already installed. The pan was complete.

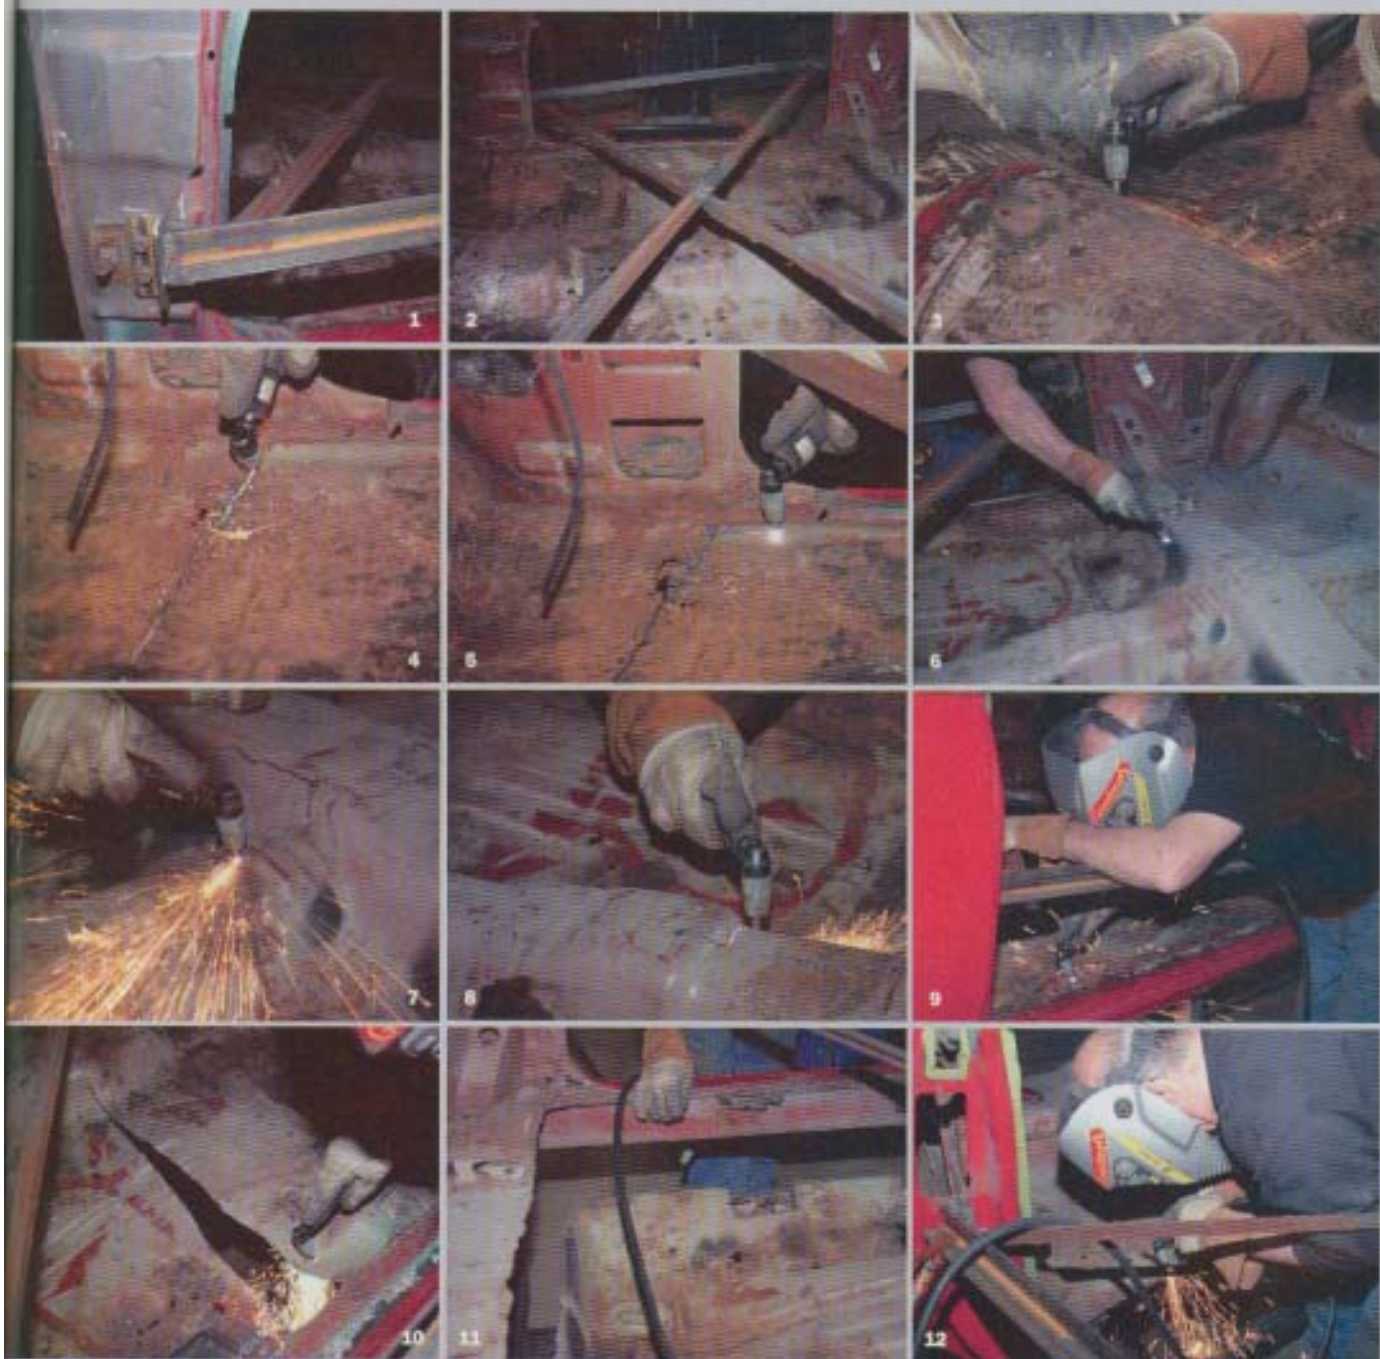
1 The entire bottom of this car is going to be removed, so much of the structural integrity of the car will be gone. To support the flexi-body, it would need triangulation, so the crew at the Installation Center made body braces that bolt onto the areas where the door hinge and door striker post mount. 2 To make the body as rigidly stable as possible and to maintain its original integrity, it required X-braces that run diagonally across the car. 3 The cutting begins. You can use various tools to do this, even a cut-off wheel or a power chisel. The Installation Center used a new ESAB plasma cutter that they wanted to try out. 4 The ESAB plasma cutter makes a smooth and quick cut and worked exceptionally well for this job. 5 It only takes minutes to get to the rocker area, and depending upon the damage in your particular car, any of those areas can be cut out and replaced with new sheetmetal as you do not want to weld the new floor pan to badly damaged panels. 6 Hopkins moves to the back of the car and begins to cut out the rear floor pan. 7 Here, the car has already been cut across the back and is now being cut down the transmission hump so that the floor can be taken out in pieces. 8 The transmission hump is still being cut, but Hopkins is now cutting between the floor braces. The object of cutting like this is to simply be able to remove large sections of the floor, and this method makes it easier. 9 Since the entire floor and the braces are going to be replaced with the new Goodmark one-piece floor, it is not essential to retain the braces, but it is important not to remove anything that is required. 10 Lock in the lower left portion of the photo, where Hopkins peeled back a U-shaped area to show where a floor brace should run. If you are simply replacing a section of the floor and plan to keep the braces, then you would cut the area out as seen here. The sheetmetal attached to the top of the brace would be chiseled away, leaving the brace. We will address this approach in a future article on installing multiple floor pieces, but for this install, that is not necessary. 11 There goes a section of the floor. It is now time to cut out the remainder of the floor. 12 Now that a section of the floor is removed, Hopkins is able to climb inside the car to continue cutting, watching carefully what he removes. The bracing you see through the sparks is the jig that the Installation Center created and built to mount the body while performing this work. As they are in the business of replacing major body components such as this, these custom-built jigs stabilize the cars.

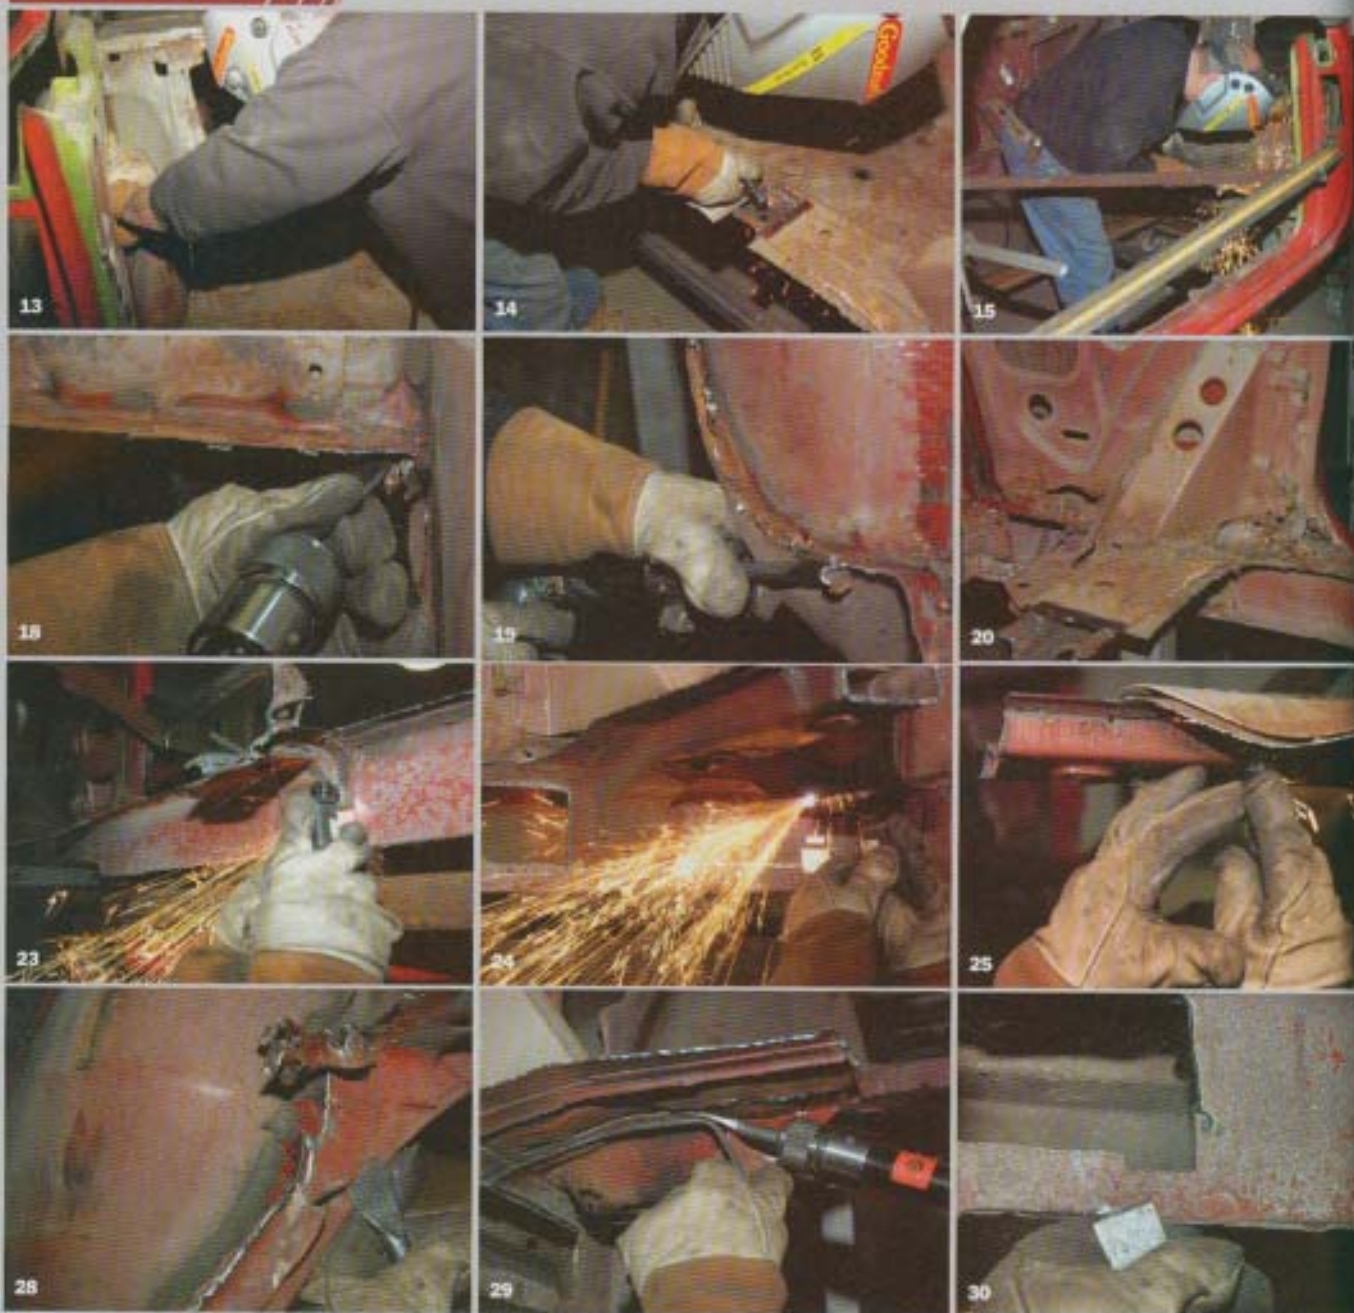
13 Hopkins cuts around the wheelhouse area and across the back of the car. Goodmark's floor pan replaces this entire area, making it all new once again. **14** Before cutting anything, it's necessary to take a good look at the original parts you are replacing as well as the new part. In the case of Goodmark's one-piece pan, it comes with all of the braces and brackets, but the brace shown here is not considered part of the floor pan. Again, be careful and diligent as you would be creating unnecessary work that would have to be addressed if you cut through it. **15** Where's the floor? This is what you sometimes find as someone had already done a hacked job on the back seat upright, so the Installation Center replaced this before the car left the shop. You will want to replace any old work that was poorly done as it makes little sense to cobble the foundation together. **16** The rest of the floor is now out of there, and it's time for cleanup to ready the area for the new floor pan. **17** Always rough-cut the floor area, and then do your cleanup work. All of the excess metal where one piece was layered onto another must be removed. Hopkins uses a chisel to slice between the two layers of metal. **18** Hopkins continues to clean the area to make the installation easier to complete. If you do not do this, then the new panel will not fit tightly when it is installed, and you'll want a tight fit for a good weld. When welding in the new piece, the areas to be bonded must be tight, or you will more than likely blow a hole through both the new piece and the old piece. If this happens, then you'll have to repair it, so do the job correctly to avoid more work than necessary. **19** The old floor pan joint must be removed from the inner wheelhouse, too. Everything needs to be cleaned on the car and ground for welding. **20** Here's a shot of the brace that Hopkins was careful to leave. He is going to lift the car and clean this area from underneath. The rust in the inner structure of the quarter panel will be repaired after the floor is installed. Don't try to do it all at one time; concentrate on one section at a time, even the small repair areas. If an area requires attention prior to the floor pan install, then do it now rather than later. **21** The body fit with the jig or frame table is lifted so that Hopkins can work from the bottom of the car. There are many ways to triangulate the car so that it is stiff and rigid while movable so that you can get to all of the areas to be welded. **22** Now that the car is up, Hopkins will remove the braces. These are already attached to the Goodmark floor. **23** Hopkins is standing inside of the car and removing any braces that attach to the inner rocker. The inner rockers are going to be replaced, so Hopkins simply cuts into this one so that a new one can be installed. **24** This is the brace that Hopkins saved. This piece sits on top of the floor pan and

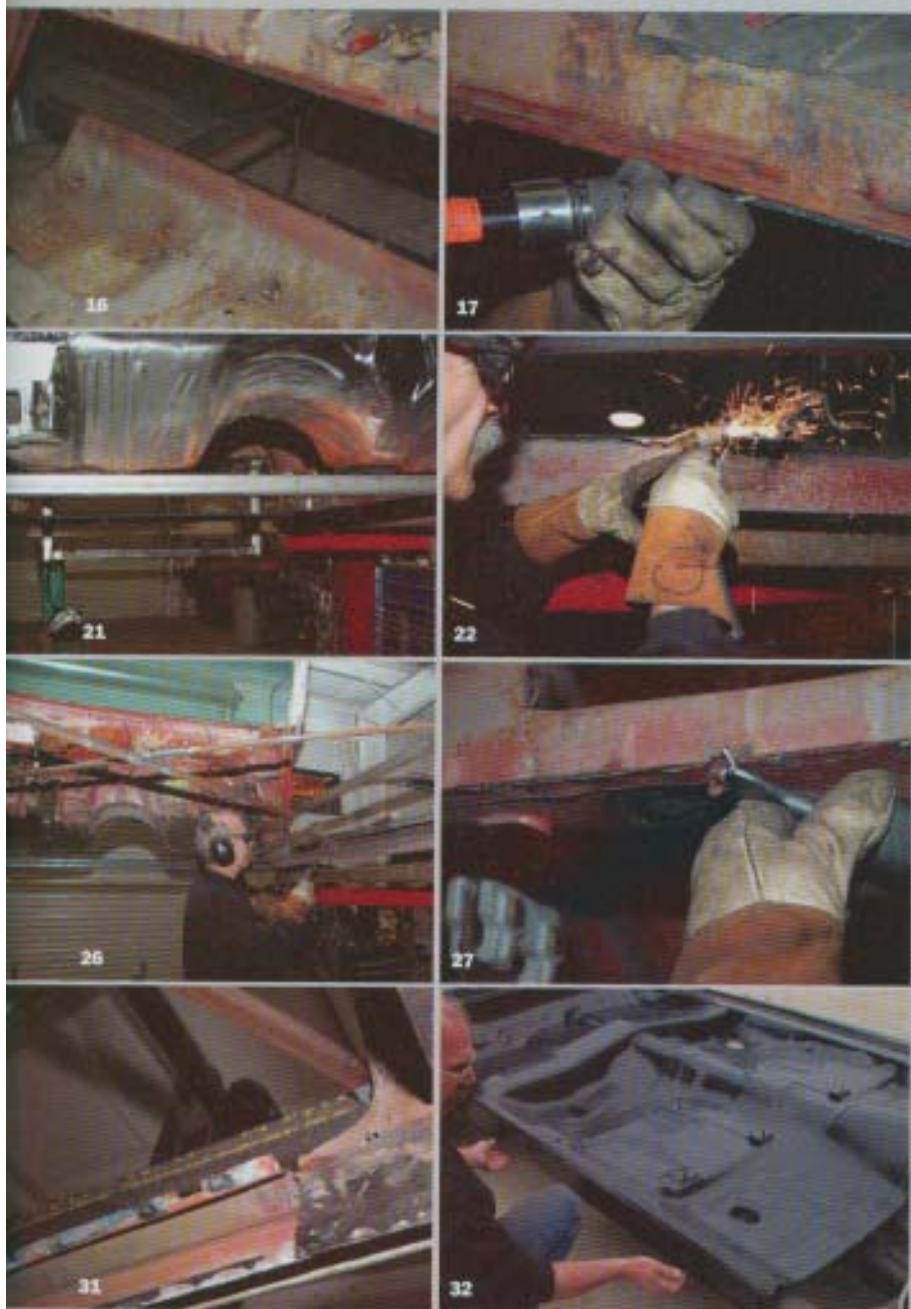
must be totally clean. **25** Hopkins starts cleaning up this brace. When he is finished, as we mentioned, only the top layer of metal will remain. **26** The cutting continues. Here, Hopkins almost has the inner rocker completely rough-cut. It will still need a lot of cleanup, but this is an important step even for a good welder. **27** Using a chisel, Hopkins keeps cleaning the old metal. Do this until all of the old metal is cleaned. **28** The floor pan was attached to the wheelhouse. Hopkins uses a chisel to remove the old pan. **29** Our same old brace is being peeled. This gives you an idea of how much work goes into a car. The best way to take a car apart is the reverse of how it was put together, so study your car and approach it in the same fashion. **30** When chiseling a panel away, the chisel is kept flat so that it won't rip into the area you wish to retain. A little practice is a good thing as these power tools can be tricky to use if you are not familiar with them. After repeating all of these steps on both sides of the car so that the entire area is clean, Hopkins is ready to install the Goodmark floor pan. **31** Hopkins uses an abrasive wheel on the areas that were spot-welded to help smooth them. Any areas that are going to be welded must have the paint removed for a good bond. If you do not want to leave these areas raw, a good weld-through primer can be used on these parts. **32** Hopkins tests the placement of the inner rocker before the initial test fit is done. Since this is a prototype, Goodmark wanted to make sure that everything was set up correctly and fit as designed before production began. As a result of all this good work, the production pieces already have the inner rockers attached.

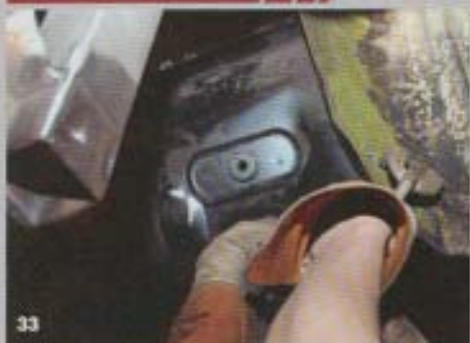
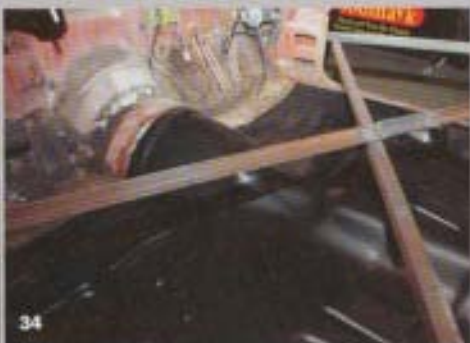
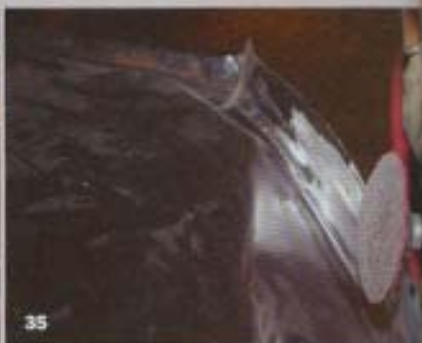
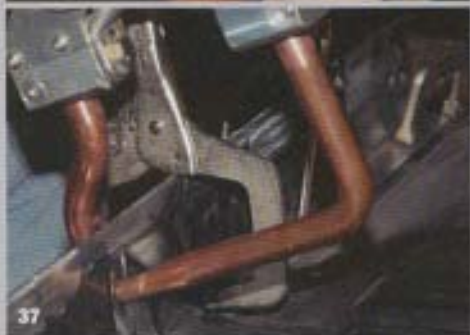
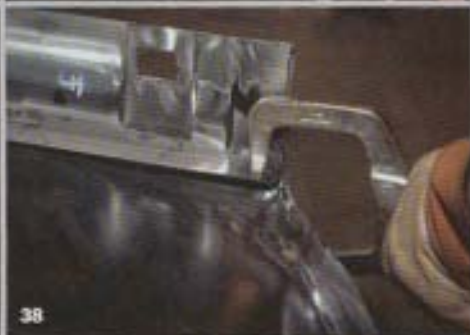
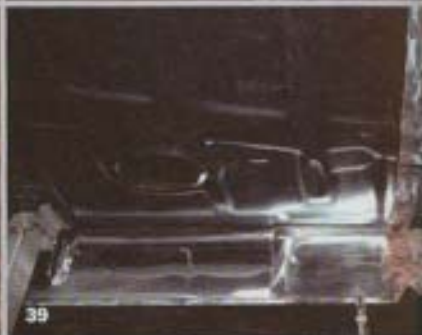
33 The floor pan is clamped into place. As you can see, the original wheelhouses are still in the car. This type of material will be replaced and covered in a future article. **34** The floor pan slipped right into place as designed, and it looks great. The work was done well going in, so there are no production problems that will require attention with the Goodmark prototype. It comes out for one final inspection by the Goodmark technicians, and then it can be final-primed for the actual installation. **35** The pan was moved to a worktable to remove the EDP (electro-deposit primer) from any of the areas that will be welded so that there will be metal-to-metal contact and good

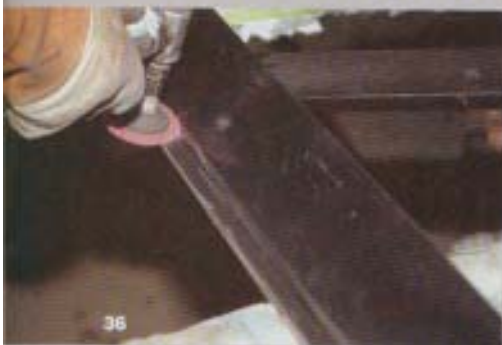
weld bonding. **36** In the production piece, the inner rockers are already attached on the Goodmark floor pan, but Hopkins wanted to test it without having the rockers installed on the prototype piece. This rocker is being prepped for installation. **37** The Installation Center tries to duplicate factory spot welds on the cars they reassemble as they never know if the car is slated to a 100-percent restoration. They do the job right, and this is a good lesson to follow. **38** The inner rocker is going to be clamped into place. The area has been sanded because it will have several welds once it is final-installed in the car. **39** After the rockers are installed, the car moves back to the lift, and the floor is readied for installation. **40** The floor is then clamped into place as it is precisely fit. Remember two things; properly locate the pan prior to clamping and welding, and weld only on clean metal. **41** This floor looks dusty but great. Check out how the braces meet the floor pan. It's a good thing that the proper work was done so that they were not accidentally chopped into. **42** The pan fits well where the new and old sheetmetal meet. Once again, make sure that the area is clean when you are going to weld. **43** A little hammer work needs to be done on the braces as good contact is important for a good weld. Because the Installation Center's spot weld won't reach this area, the holes are to be plug-welded. **44** Factory spot welders demand a clean surface and good contact. Hopkins makes sure that the arms are in place. **45** The metal to be spot-welded must be tight and clean. Keep clamps close to the area to be spot-welded, or you will blow a hole in the metal. **46** You can see that the lower and inner rockers are clean and have welds every few inches so as not to distort the sheetmetal. **47** Hopkins plug-welds this area. A plug weld is a very strong weld. **48** Once this area is completed, the other side of the car will get the same treatment. Any areas of raw metal will then be put into primer. As you can see, this is a very smooth and nice-looking installation. If you hadn't seen it presented in a step-by-step manner, you would likely never know that this wasn't the original floor in the car. The installation looks as good from the bottom as it does from the top, and with a little patience, you can duplicate this same work at home, but it might take you longer than it did the crew at the Installation Center.
